Appendix L

Cost of Techniques

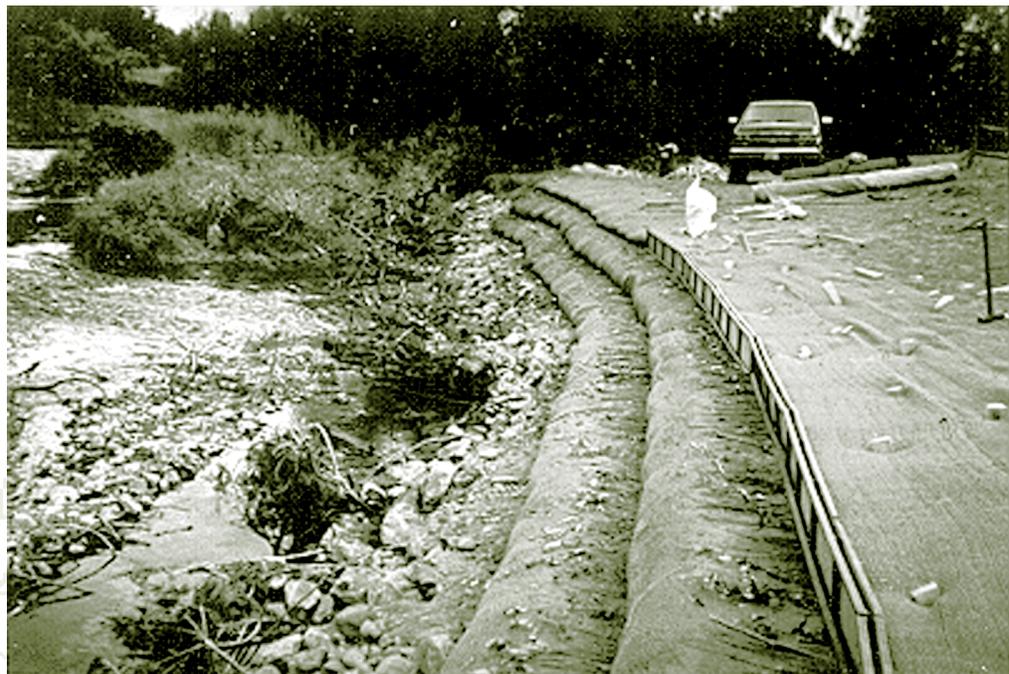
Most sites within the project area incorporated a rock toe with reinforced soil lifts and vegetation. Bank height varied from four to six feet, and protection measures included two to four soil lifts. A rock toe offers relative permanence to the bank location, while soil-reinforced lifts offer immediate protection against all flows and a long-term opportunity for healthy native riparian vegetation to thrive. *Figure L-1* shows one of the project sites after construction.

Figure L-1. Salmon Creek bank protection using rock toe, soil-reinforced lifts and vegetation.

Project components consisted of rock toes and soil reinforced lifts planted with riparian grass-seed mix and vegetative cuttings. Materials included existing soils, imported angular rock, coir fabric (woven and nonwoven), wooden stakes, riparian grass-seed mix, willow and dogwood cuttings. Equipment used on site included dump trucks, a loader and a tracked excavator. No dewatering was used. Sediment control consisted of temporary in-channel silt barriers.

The average cost per foot of treated bank was approximately \$100 (linear foot of bank), translating to an average of \$10,000 per site, not including design, permitting or mobilization.

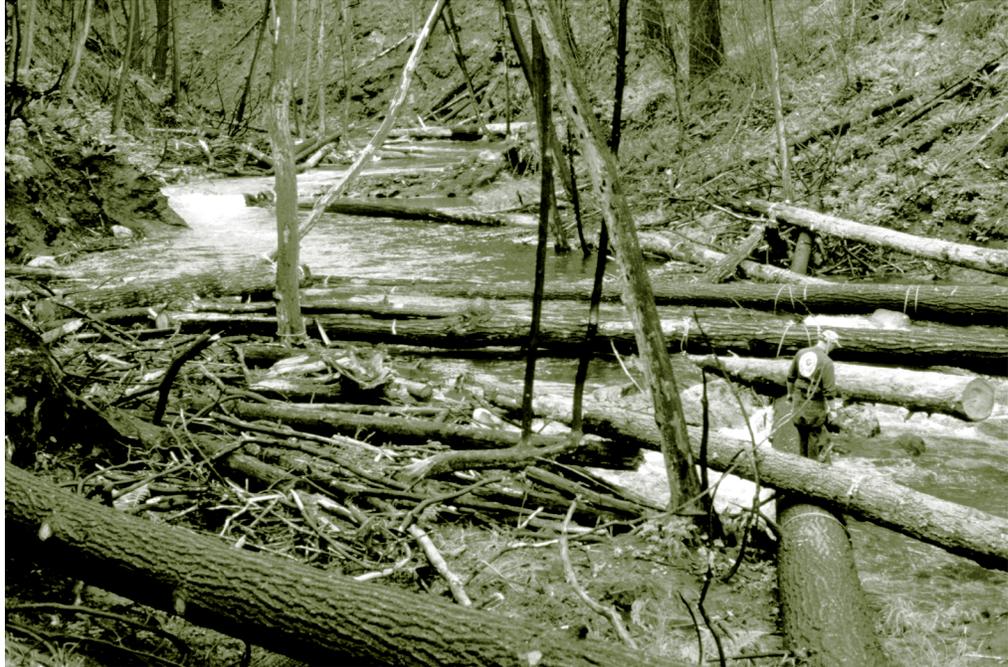
Project components included installation of three engineered log jams. *Figure L-2* shows the project after construction. A Hilti® fastening system was used to drill and cable trees to key rocks. The increased ballast was used to simulate the drag force obtained by using trees with rootwads. All wood used was from felled trees adjacent to the creek. Galvanized-steel core cable and cable clamps were used to anchor the large wood in place. Other equipment used included: battery-operated Hilti® drill, glue, chokers and a winch mounted on the walking excavator used by workers to pull themselves out of steep areas. No dewatering was used.

Figure L-2. Engineered log jams on Whatcom Creek.

The cost for installing three log jams (using on-site large woody debris) was approximately \$9,000, not including design, permitting or site access costs. The estimated cost to accomplish the same project with imported, two-to three-foot-diameter, large woody debris was \$27,000.

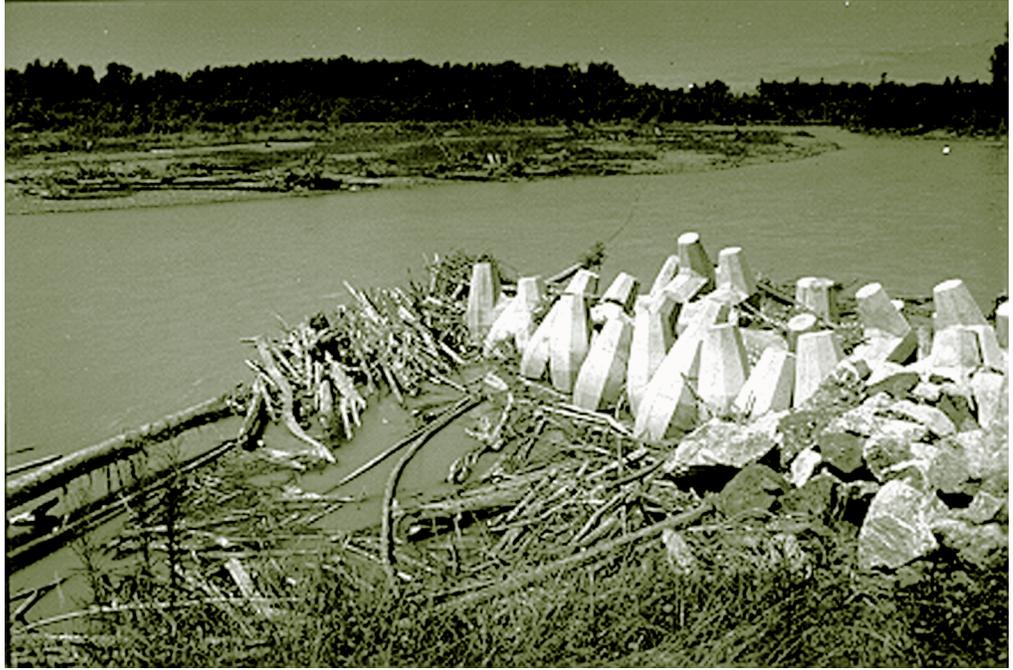
Two separate sites were protected. The first site, a 2,100-foot reach, consisted of concrete dolo groins constructed using a large-diameter, angular-stone foundation, with large doloes on the upper portion to simulate and trap large wood. The concrete dolo groins form permeable “noses” that collect woody debris more readily than the nonporous, all-rock, groin type (see *Figure L-3*). The second site, a 1,000 foot reach, consisted of 10 woody groins constructed of 16-inch-diameter (minimum), untreated timber pilings installed to a 25-foot depth, cross logs and rootwads with riprap scour protection at the base of each groin (see *Figure L-4*).

Figure L-3. Concrete dolo groins on the Nooksack River.

Project components included constructed groins, installed woody debris among groins, resloping and revegetation of bank slopes between groins, and a detailed monitoring and maintenance program. Materials for the concrete-dolo groins included large-diameter (four-foot) angular rock; large, concrete armor units (25 to 40 per groin); imported woody debris; and rootwads cabled to ecology blocks with braided cable and clamps. Materials for the woody groins included straight timbers, logs with rootwads and cables. The project also included bank resloping, included hydroseeding with grass species, installing unrooted willow cuttings and planting bare-root riparian trees and shrubs. In addition, cutback trenches were incorporated at the ends of treated banks, which consisted of a launchable riprap pad within an excavated and backfilled trench. Equipment included excavators, dump trucks and loaders.

The cost for the dolo-groin treatment was approximately \$440 per linear foot of bank. The cost of the woody-groin treatment was approximately \$155 per linear foot of bank.

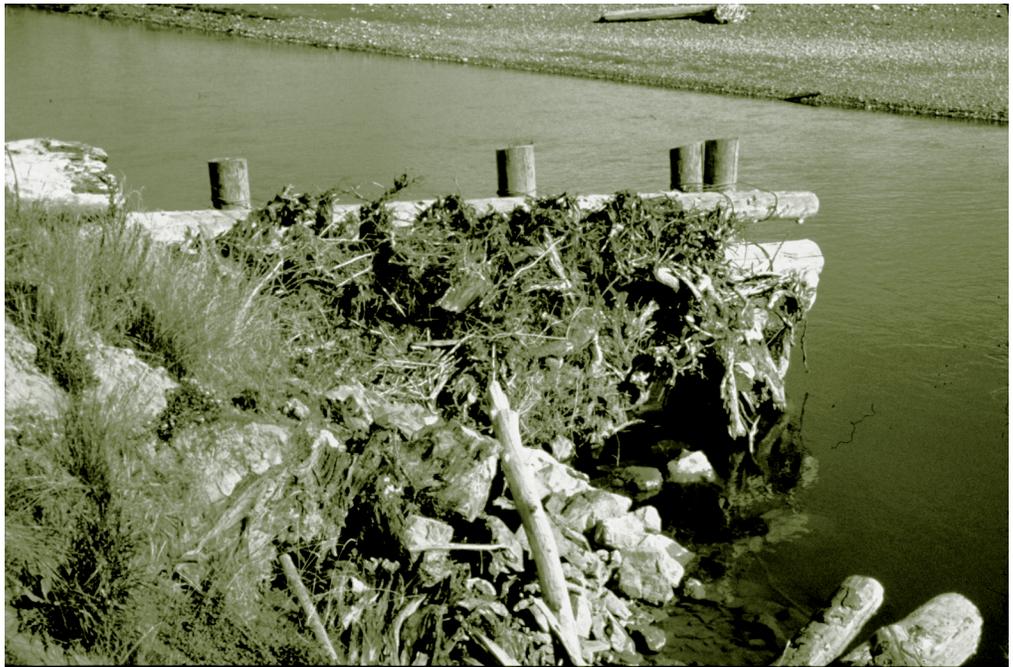
Figure L-4. Woody groins on the Nooksack River.
